# Prometheus Propulsion CDR

5/7/24

**ROCKET**  
PROJECT AT UCLA

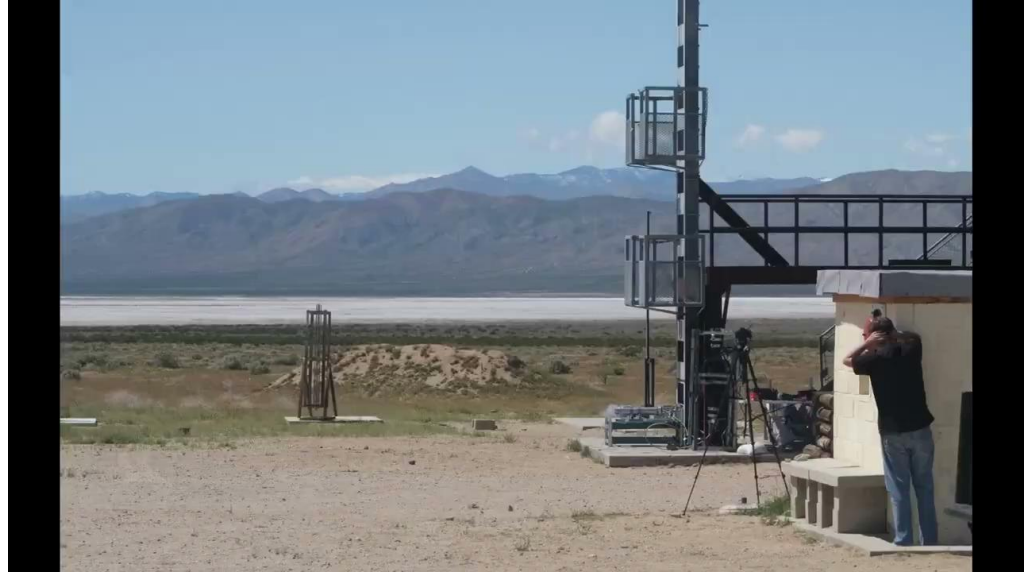
# Hotfire #2 - Engine 1

- Moving K-Bottles to the shade too early made our K-bottles run at a lower pressure than anticipated (700 PSI)
- Poor nozzle manufacturing, large orifice area, and poor injector stiffness meant we had crazy combustion instability
- Poor nozzle/liner integration meant we burned through their interface at the bottom of the engine

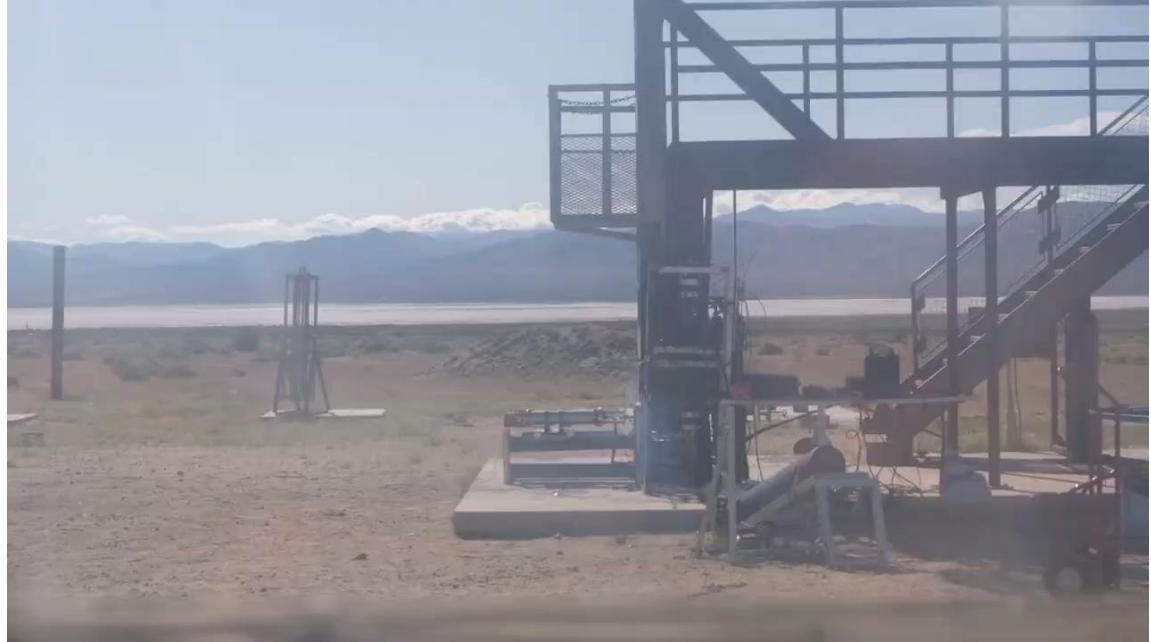
# Hotfire #2 - Engine 2

- We were able to very quickly switch out engines and re-do high press checks
- We were able to get bottles to an initially higher temp, but we over-filled ox and immediately dropped back to our lower pressure
- We still suffered from pretty bad combustion instability
- Same nozzle/liner burnthrough
- Integration of hard line helped us reduce feed system losses

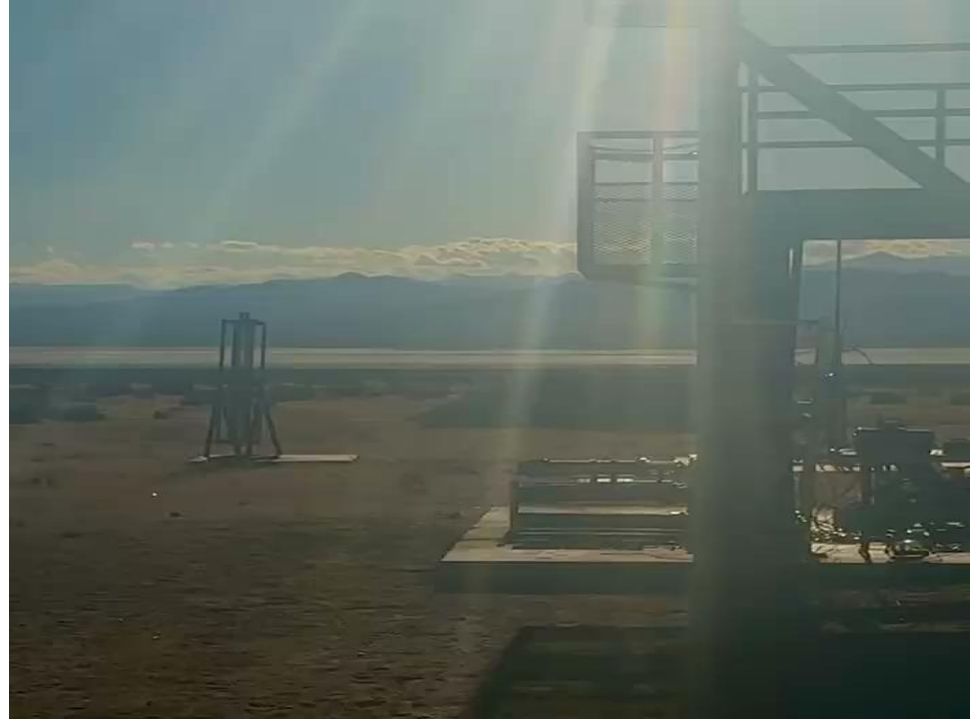
# Hotfire 3 - Engine 3

- Same Nozzle issue
- Post-fire inspection revealed that the throat and 1" of the diverging section stayed intact, validating that we had successfully prevented burn-through
- Total impulse and nominal thrust were slightly lower than expected
- Longer Burn time decided to be a non-issue, given resolution of burn-through

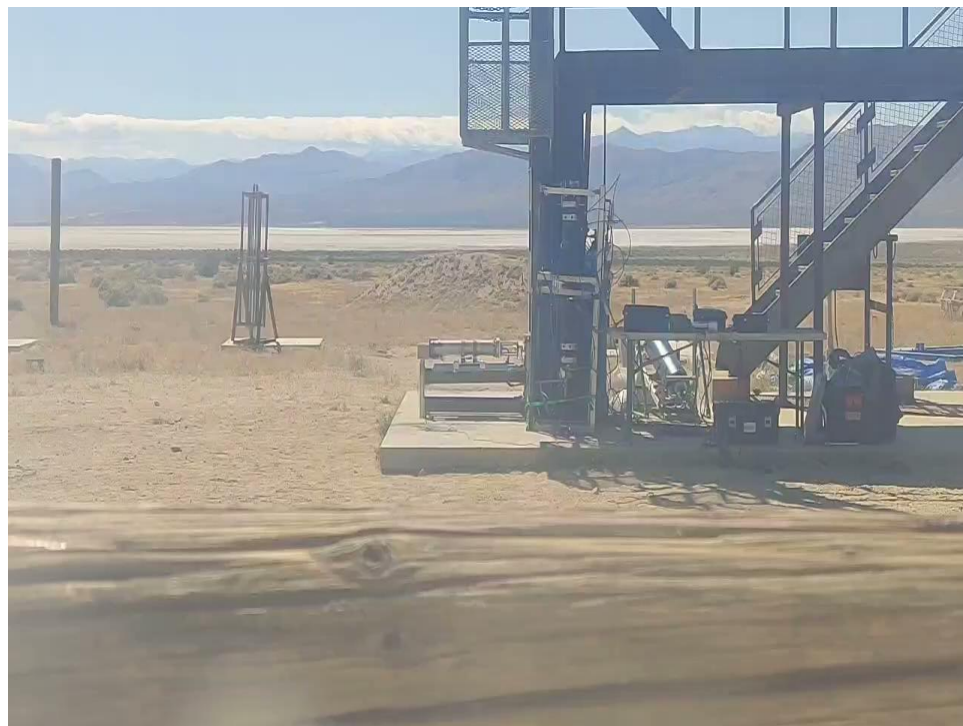
# Hotfire 3 - Engine 4

- Nozzle flew out roughly 3 seconds into burn
- Post-fire inspection revealed that the throat and .5" of the diverging section stayed intact, validating that we had successfully prevented burn-through
- Total impulse and nominal thrust were lower than expected

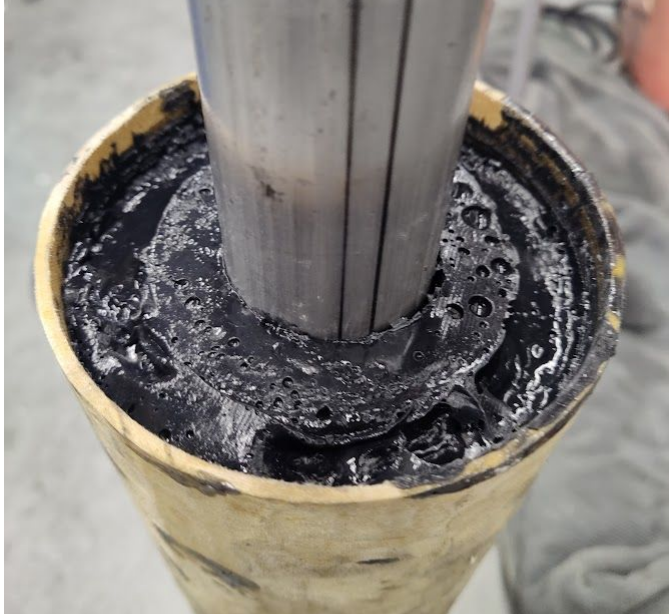
Fuel grain sank during curing

| Issue | Design Change | Justification |
|---|---|---|
| Fuel Grain sank during curing | <b>Added Pre CC</b> to fill in void and integrate with injector | Several sources attribute Pre CC to better propellant mixing<br>Outer ring of orifices on injector would be blocked by fuel grain without Pre CC |

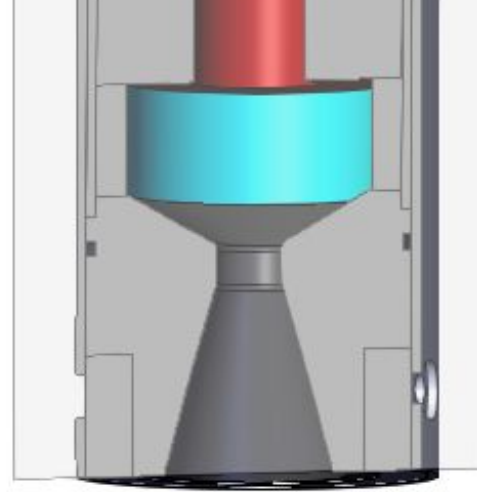
Initial Nozzle - CC O-ring

| Issue | Design Change | Justification |
|---|---|---|
| Nozzle O-ring would always tear during integration | <b>Removal of Nozzle - CC O-ring</b> and replaced with surplus of RTV | O-ring had no actual functionality, gas would burnthrough at chamber before contact with O-ring |

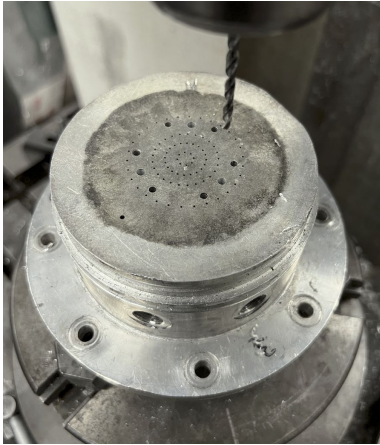
Adding 6 x  $\frac{1}{8}$ "  
holes to injectors

| Issue | Design Change | Justification |
|---|---|---|
| Low $\dot{m}_{ox}$ (lower Cd than expected) | <b>Added 6 x 1/8" holes to injectors</b> increasing orifice area and raising our $\dot{m}_{ox}$ | Coldflow and waterflow tests exposed a lower Cd than expected, lowering our mdot and resulting in a long flow time; thus mdot was raised to decrease this flow time |

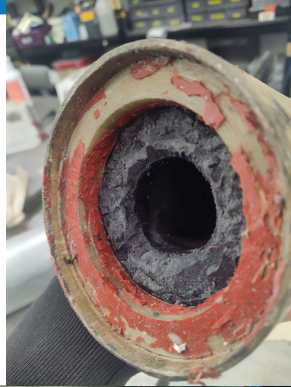
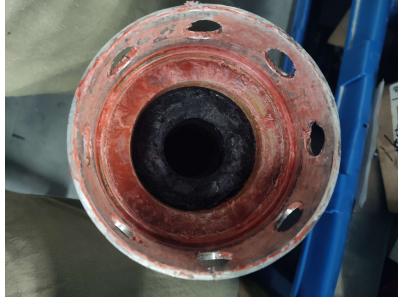
Decreasing RTV

| Issue | Design Change | Justification |
|---|---|---|
| Low $\dot{m}_{ox}$ (blocked orifices from RTV) | <b>Reduced RTV application</b> on injector-pre CC seal | Prevent outer ring of orifices from getting clogged with RTV |

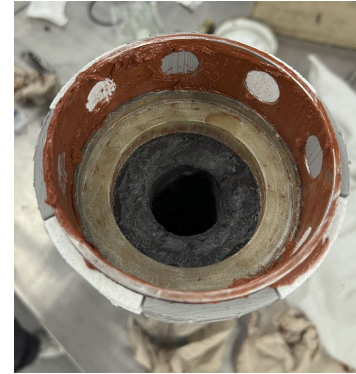
Radial Hole Fillers

| Issue | Design Change | Justification |
|---|---|---|
| Torn Injector-Chamber O-ring | <b>Implementation of PLA radial hole fillers</b> to provide smooth surface for o-ring integration | Injector-Chamber O-ring would catch on the radial holes and tear. Hole fillers held radially by hose clamp minimized tears |

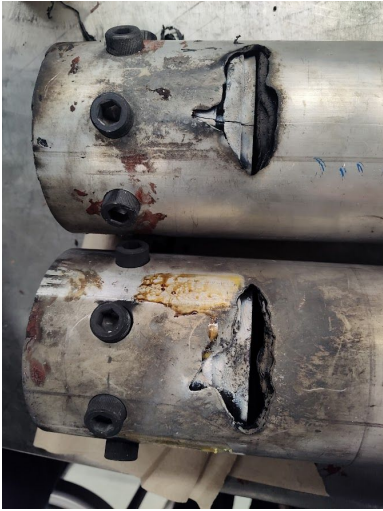
Burnthrough on both engines at post CC - nozzle interface

| Issue | Design Change | Justification |
|---|---|---|
| Burnthrough at Nozzle-Liner Seal | <b>Added nozzle step into post-CC</b> | Increased labyrinth sealing to further prevent burnthrough by cooling hot gas |

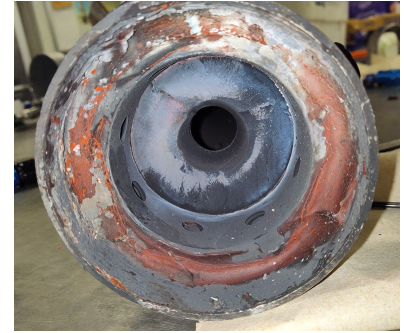
| Issue | Design Change | Justification |
|---|---|---|
| Nozzle Sheared (E1) | <b>Chamfered RR</b> on the nozzle-interface side, smoothing out RR ID - nozzle interface (E3) | Nozzles cracked and separated at the throat. Suspected cause: sharp ID of RR chipped into the nozzle inset filet causing a stress crack. |

Nozzle Shear at RR plane

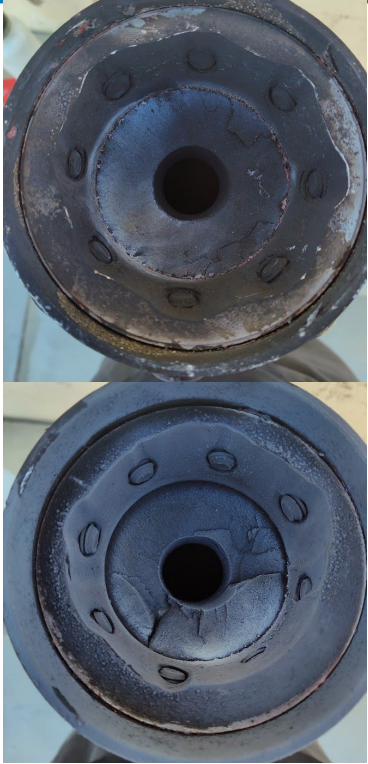
| Issue | Design Change | Justification |
|---|---|---|
| Shearing of both nozzles at retaining ring plane | <b>Retaining ring moved below nozzle</b> instead of inset around nozzle, de-constraining nozzle radially | Suspected cause of shearing: RR and CC radially constrained the nozzle at different surfaces. When the graphite thermally expands from the combustion, the difference in distance causes reaction force in direction opposing thermal expansion, causing shearing at RR plane. Moving RR below nozzle eliminates problem, acting as a bigger snap ring (which was not feasible to manufacture due to chamber thickness) |

Shearing of both  
nozzles at RR plane

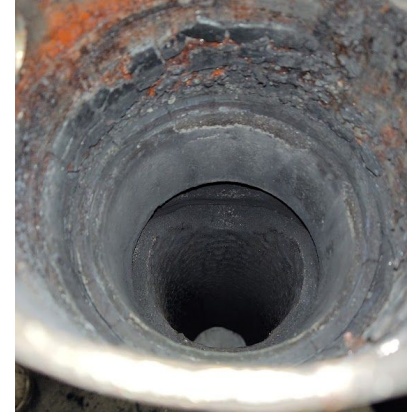
| Issue | Design Change | Justification |
|---|---|---|
| Near burnthrough at grain - post CC seal (CC wall internally exposed) | <b>Adding grain - post CC step</b> with post CC sticking into fuel grain, increasing compression during integration (0.25" -> 0.4") | Increase labyrinth sealing, gas will hit post CC before liner if the seal is not formed properly. The near burnthrough only occurred in E3, suggesting the sealing issue stemmed from integration error. Increasing compression will decrease chance for error and improve sealing (target 2 tons of compression).. |

Severe ablation at  
grain - Post CC seal
