# Prometheus Propulsion CDR

5/7/24

**ROCKET**  
PROJECT AT UCLA

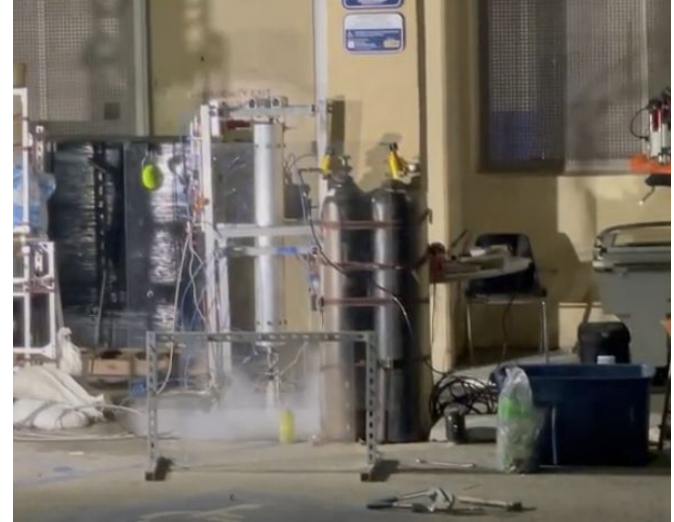
# Coldflow 1

- Flow was way to long (20 seconds observed ~ 6 seconds expected)
- CO2 was at a pressure of ~550 PSI
- GSE+Fill systems took extremely long time to leak check
- QD successfully disconnected
- No injector connected

- GSE secured their fill table to remove shakiness
- Feed system upsized for better flow
- Feed valves tested to ensure full activation

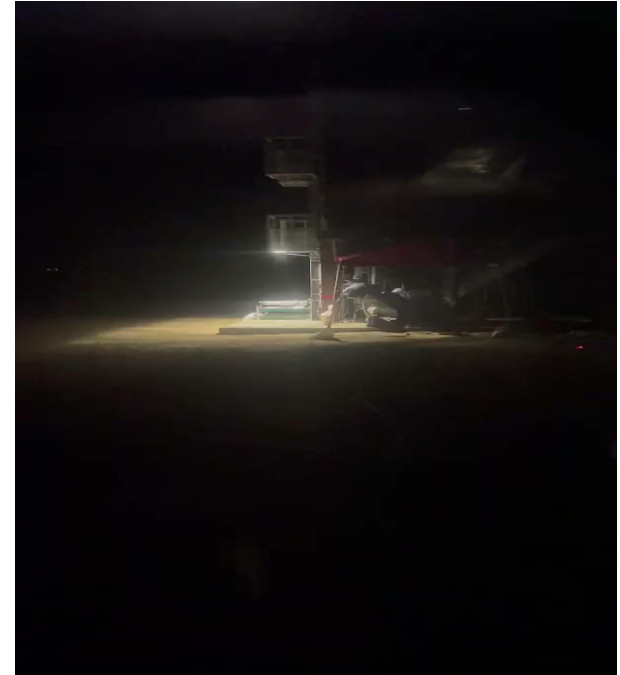
# Hotfire 1

- Last-minute changes to fill table + feed system meant that leak checks took a very long time
- Confusion about ignition procedures led to multiple scrubbed fires from ignition failure
- Extreme cold + hail meant K bottles only reached ~500 PSI
- Poor engine integration blocked a significant amount of the injector orifices, making flow time 23 seconds

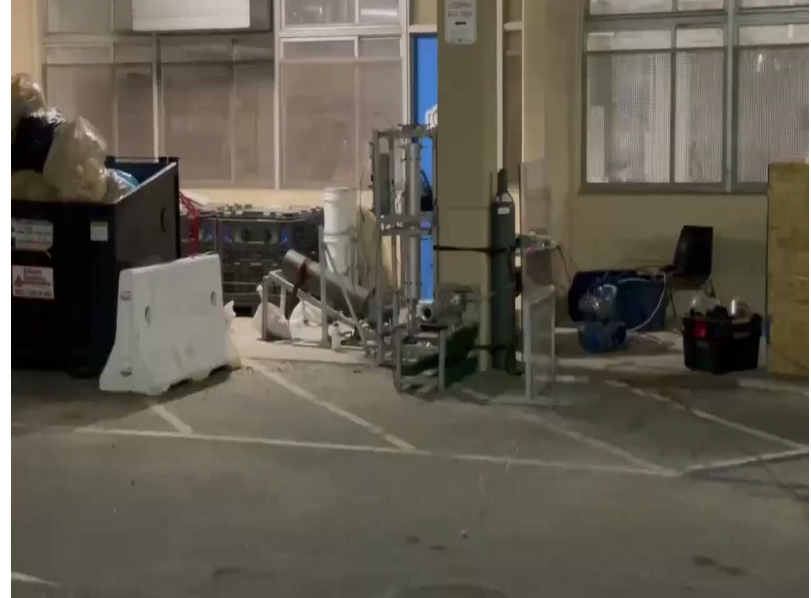
# Coldflow 2

- Used test stand+bottle inverter to simulate hotfire setup and check system pressure losses
- Implemented changed procedures for better ignition / more effective safe stating
- CO2 bottles only reached ~650 PSI
- Long flow time indicated that we needed to open up injector / reduce feed system pressure losses (still 20 seconds)

- De-Integrated Engine, drilled more injector orifices
- Waterflowed, remanufactured Feed System for full valve actuation

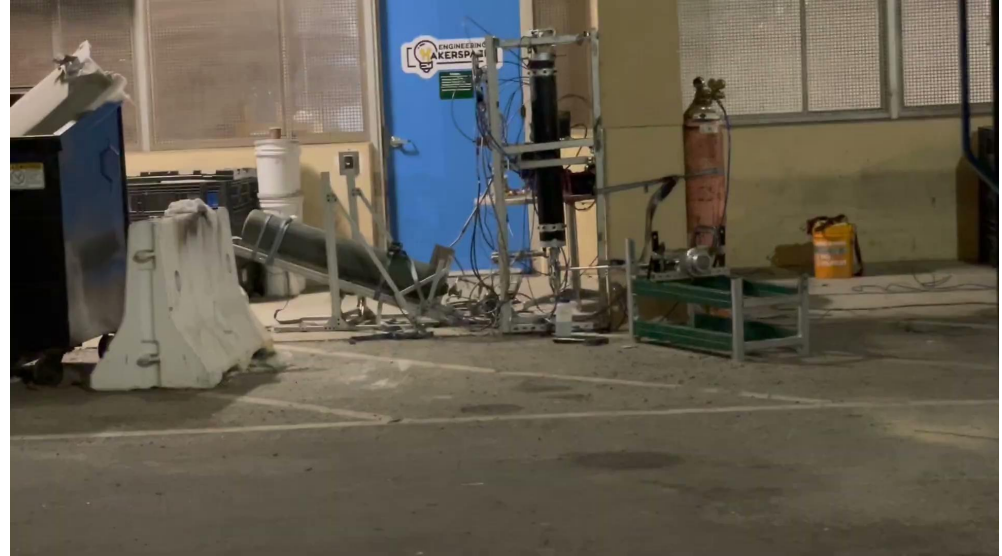
# Coldflow 3

- Proved that mass flow issues were improving (9 seconds to dump all liquid)

- We hadn't finished new bracket for feed which was implemented after this flow
- Minimal System changes as flow time was closest to correct yet

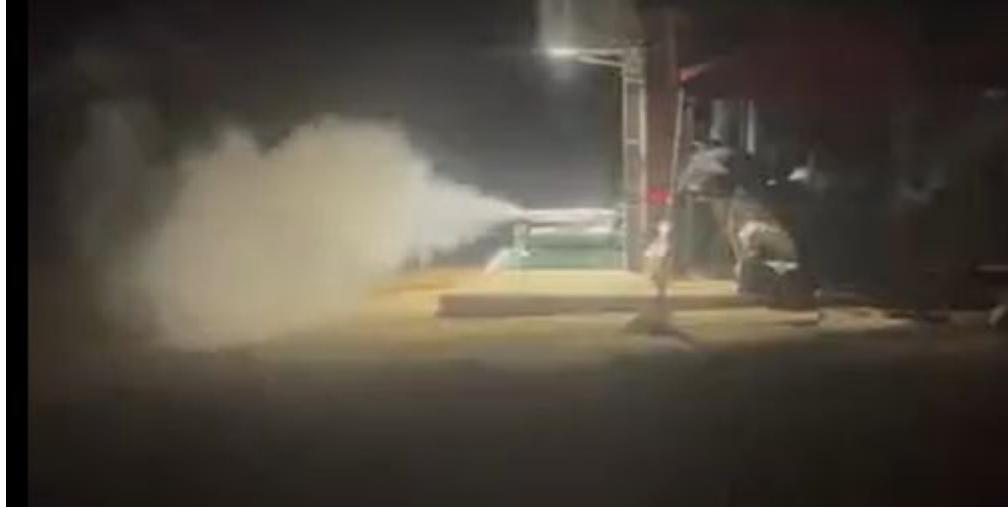
# Hotfire 1 Engine Recap

- Ignition failure
- Extended flowtime ( $\sim 20$ s)

| Issue | Design Change | Justification |
|---|---|---|
| Failed Ignitor (faulty ignition sequence) | <b>Cast new in-house ignitor</b> with redundancies (2 e-matches, flammable solid motor shavings) and update ignition sequence<br>Composition: Al, CuO, $KClO_4$ , Silicone Mix) | MPV opened before ignitor could heat up, several ignition tests to determine new countdown:<br>T-3: ignite, confirm ignite, T-0: MPV |

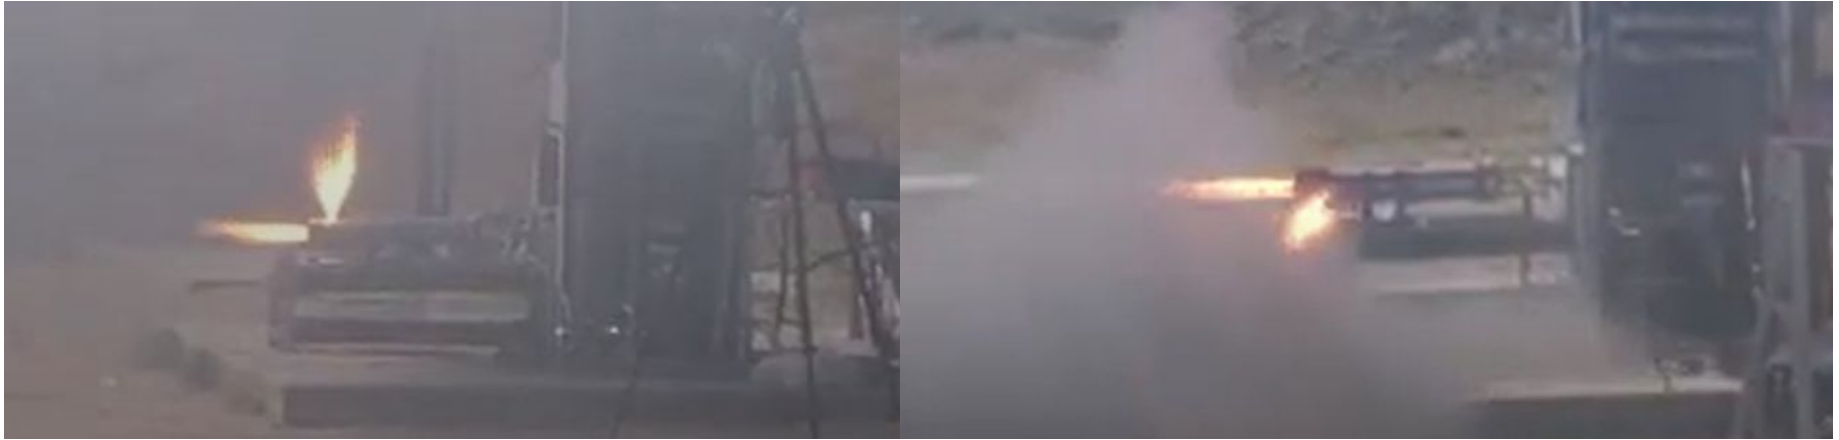
# Hotfire 2 Engine Recap

- Successful ignition
- Burnthrough of both engines
- Extended burntime (~16s)
- Nozzle Shear

| Issue | Design Change | Justification |
|---|---|---|
| Burnthrough from long burntime (low $\dot{m}_{ox}$ ) | <b>Added 3 x 1/8" holes</b> to injectors | Increasing area to increase $\dot{m}_{ox}$ to decrease burntime |
| Burnthrough at Nozzle-Liner Seal | <b>Added nozzle step into post-CC</b> | Increased labyrinth sealing to further prevent burnthrough by cooling hot gas |
| Nozzle Sheared (E1) | <b>Chamfered RR</b> on the nozzle-interface side, smoothing out RR ID - nozzle interface (E3) | Nozzles cracked and separated at the throat. Suspected cause: sharp ID of RR chipped into the nozzle inset filet causing a stress crack. |

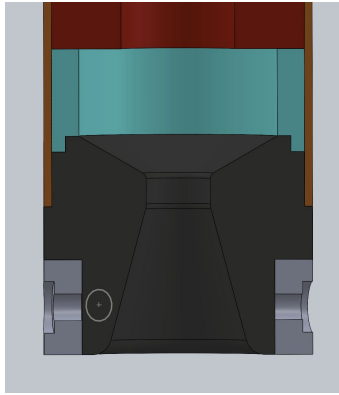
Burnthrough on both engines at post CC - nozzle interface

Post CC step into nozzle  
Extended liner into nozzle

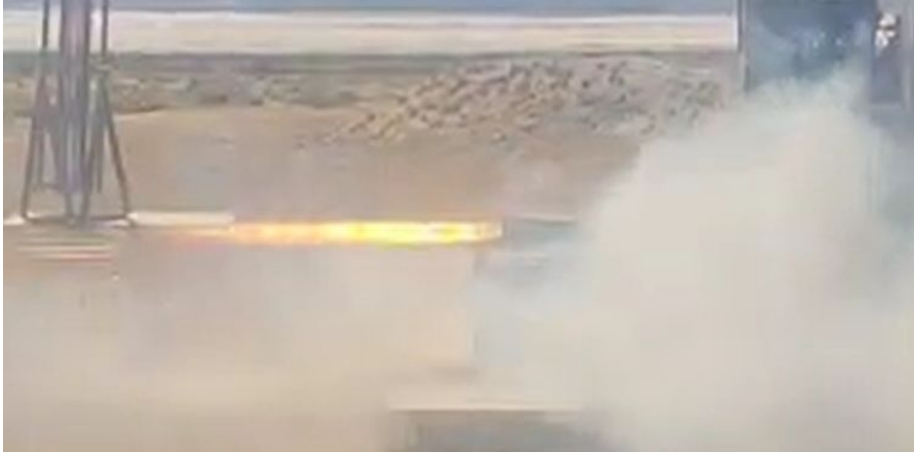
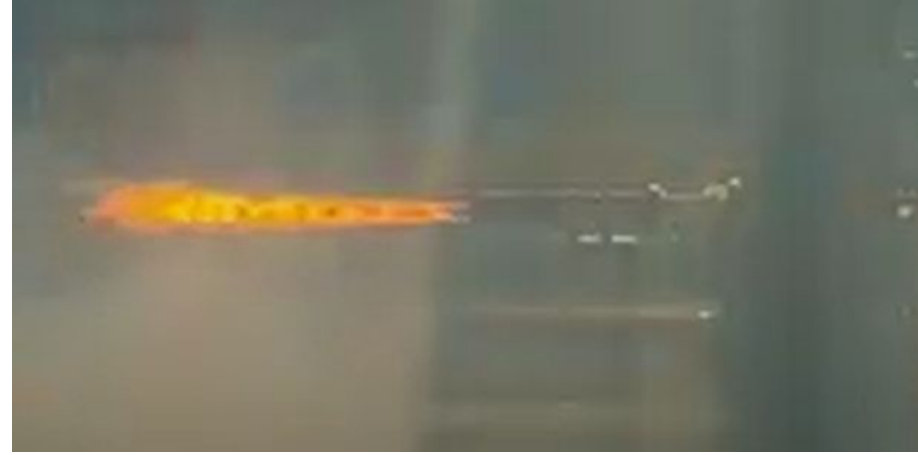
# Hotfire 3 Engine Recap

- Successful ignition
- Burnthrough prevented
- Nozzle Shear
- Extended Burntime ( $\sim 15s$ )

| Issue | Design Change | Justification |
|---|---|---|
| Shearing of both nozzles at retaining ring plane | <b>Retaining ring moved below nozzle</b> instead of inset around nozzle, de-constraining nozzle radially | Suspected cause of shearing: RR and CC radially constrained the nozzle at different surfaces. When the graphite thermally expands from the combustion, the difference in distance causes reaction force in direction opposing thermal expansion, causing shearing at RR plane. Moving RR below nozzle eliminates problem, acting as a bigger snap ring (which was not feasible to manufacture due to chamber thickness) |
| Near burnthrough at grain - post CC seal (CC wall internally exposed) | <b>Adding grain - post CC step</b> with post CC sticking into fuel grain, increasing compression during integration (0.25" -> 0.4") | Increase labyrinth sealing, gas will hit post CC before liner if the seal is not formed properly. The near burnthrough only occurred in E3, suggesting the sealing issue stemmed from integration error. Increasing compression will decrease chance for error and improve sealing (target 2 tons of compression).. |

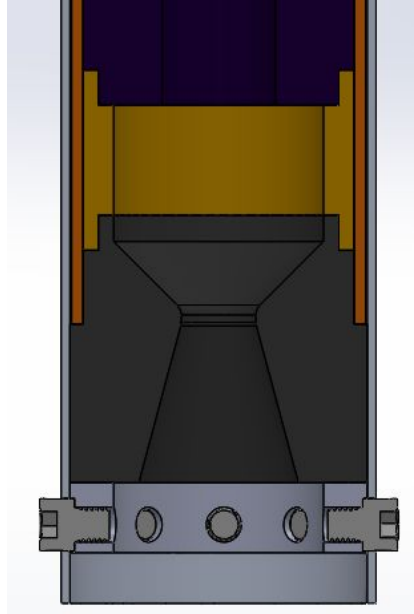
Shearing of both  
nozzles at RR plane

Retaining ring below nozzle  
Post CC step into grain
